Acct: 1713.01 Date: 06 / 11 / 2015

City: CLEARWATER

Year Built: 1985 Sq Footage: 1620

4 POINT VISUAL INSPECTION (4POINT) - PAGE 1 OF 2

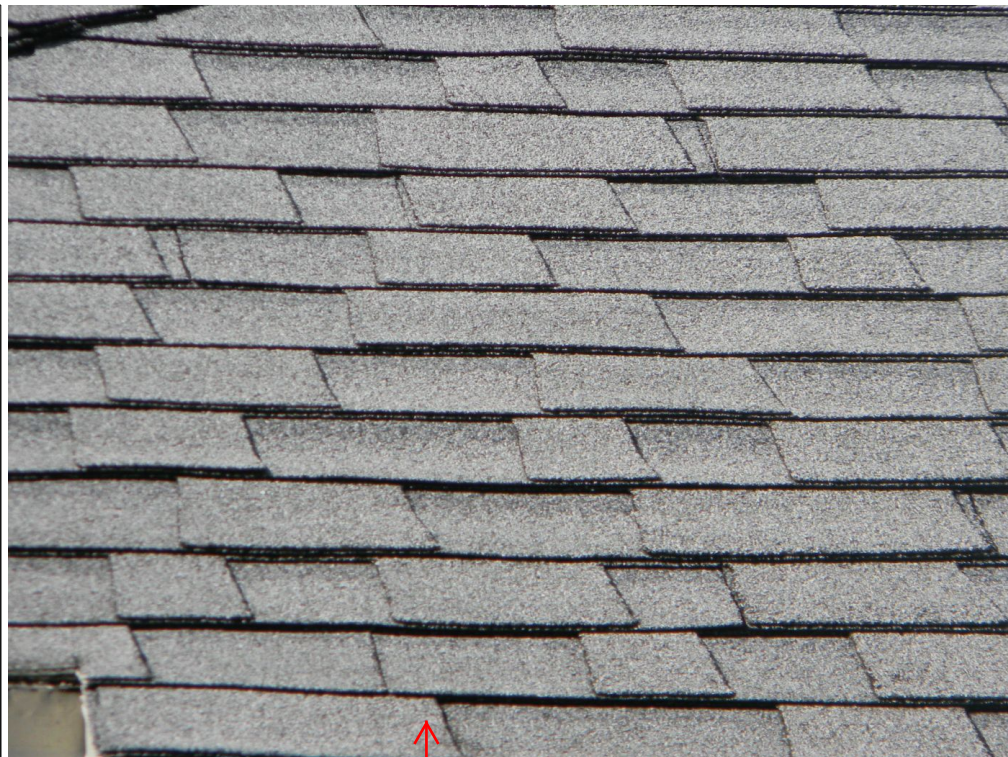
Roof

Roof. The roof cover is architectural shingle and the roof shape is gable. The roof is approximately 10 years old and is in good condition. The estimated remaining life expectancy is 15 years.

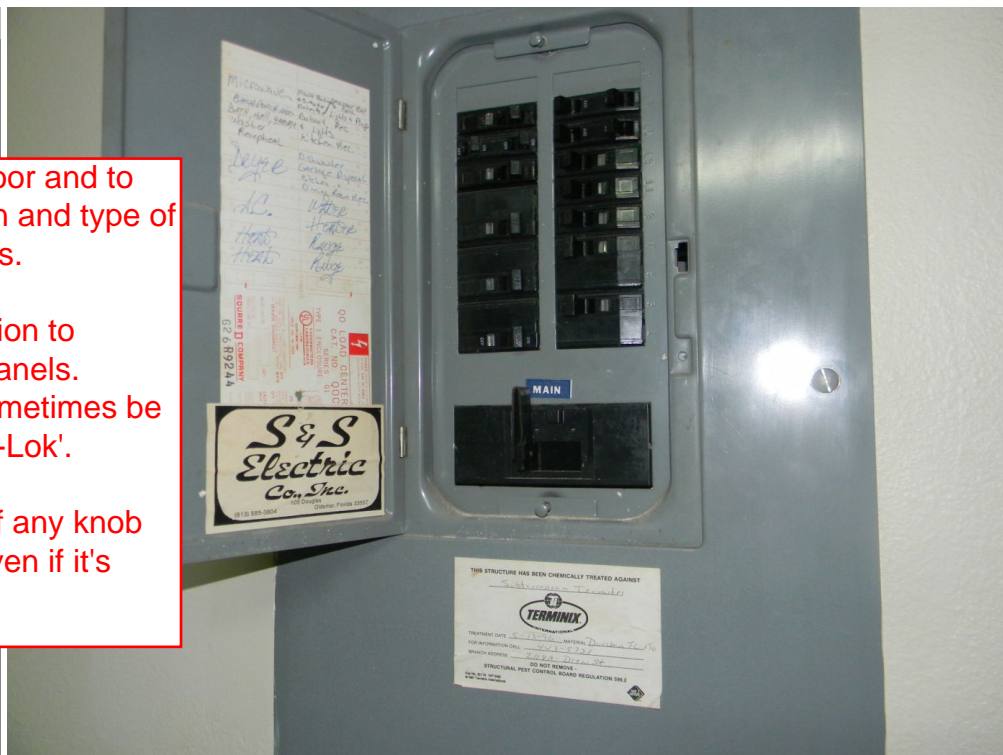
Electrical Panel

Electrical System. The system is original construction. The system is in good condition and the estimated remaining life expectancy is 25 years.

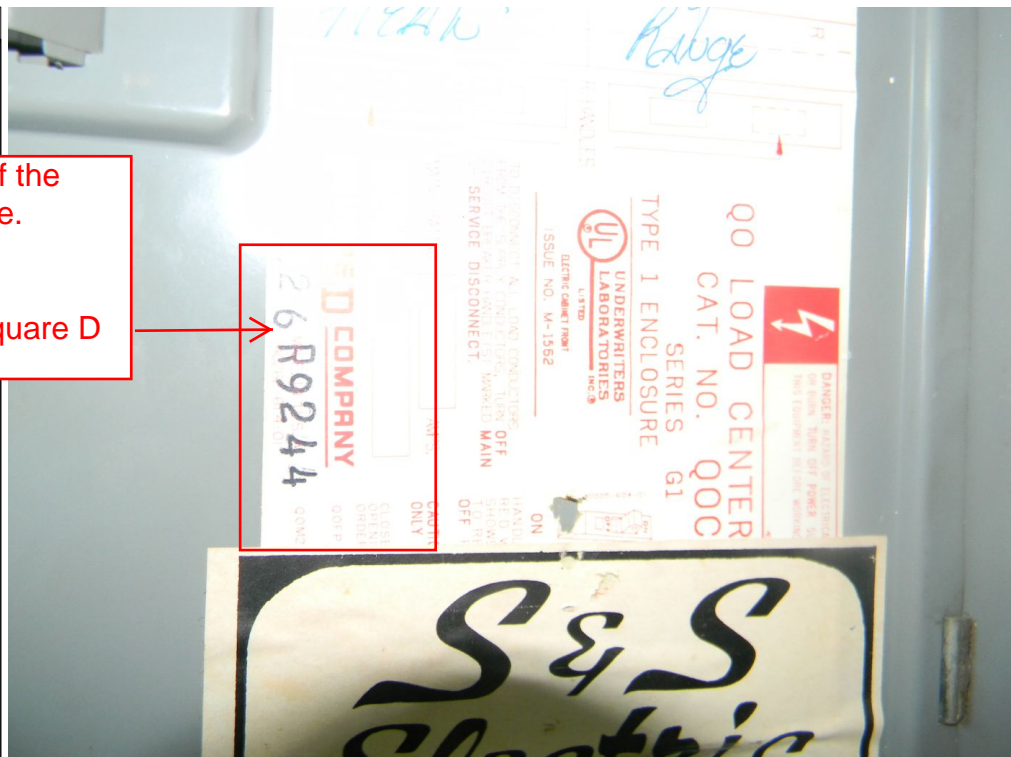
Manufacture name

In this case the manufacture is Square D

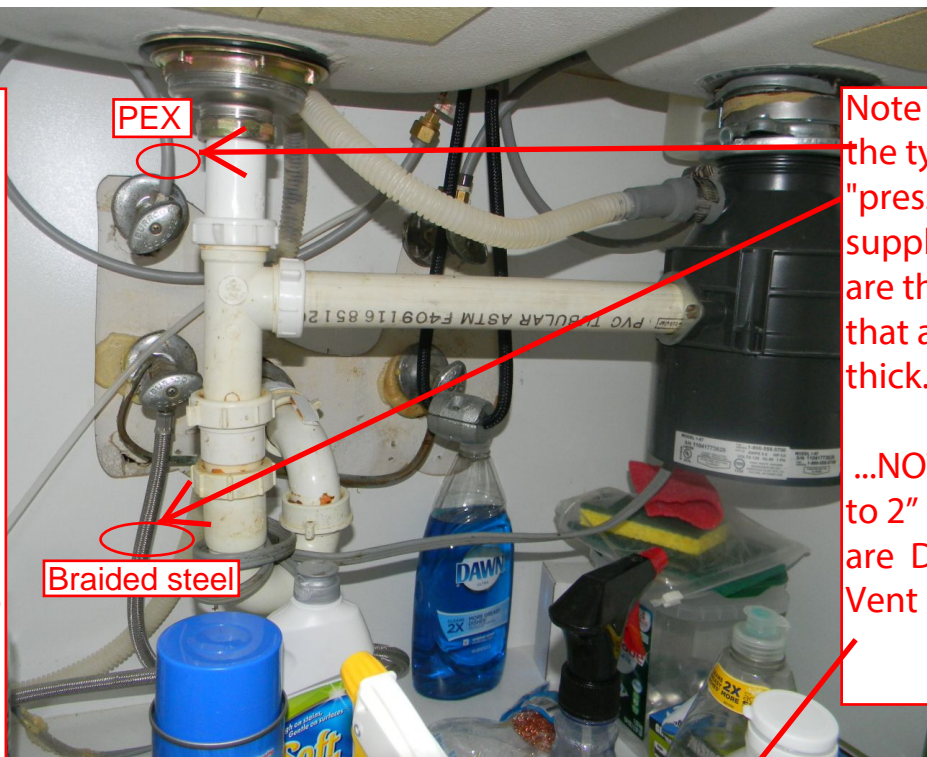
Plumbing Under Sink

Plumbing System. The kitchen and bathroom fixture supply lines appear to be about 5 years old. The water heater is about 5 years old and in good condition. The estimated remaining life expectancy is 12 years.

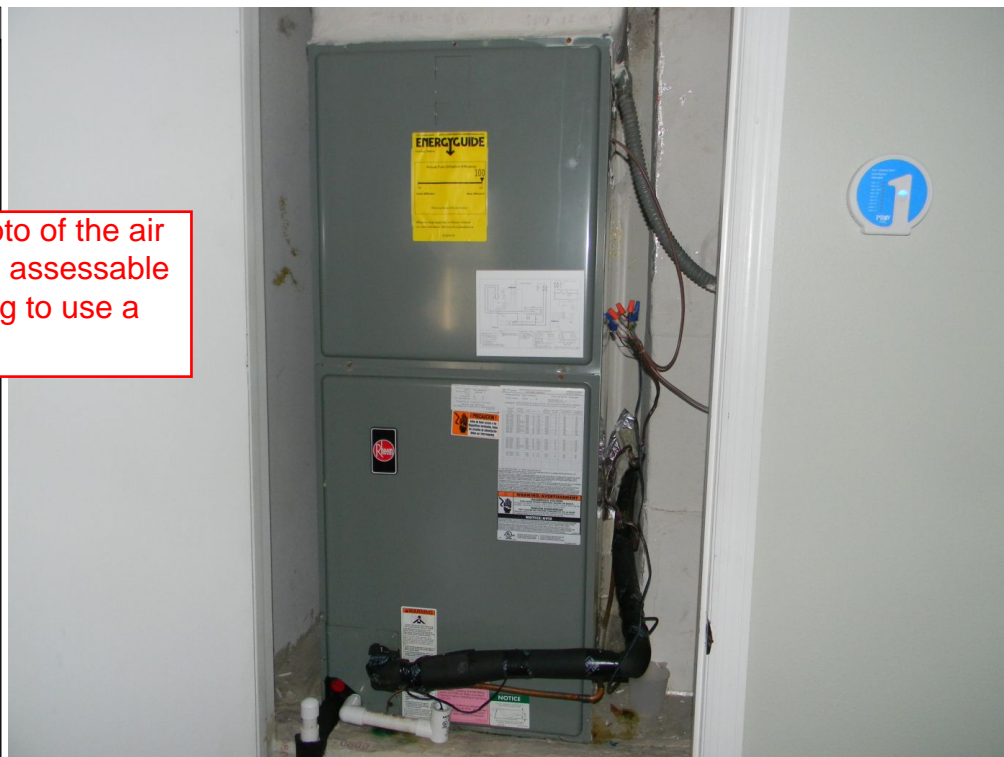
Air Conditioning

Heating/Cooling System. There is a central HVAC system with a built-in heat pump. The system was updated in approximately 2011 by a professional contractor. The HVAC system is a forced air system with separate ducts. The air handler is located in the garage. The system is in very good condition and the estimated remaining life expectancy is 12 years.
