Client Name: AMERICAN INTEGRITY INSURANCE

Policy #: AGD341397
Tracking #: 15-243-000375

City: BRADENTON State: FL Zip: 34203
 Telephone: Coverage Amount: 240000.0000 Year Built: 1996 Square Footage: 1483

INSPECTION SURVEY -- OVS-W2

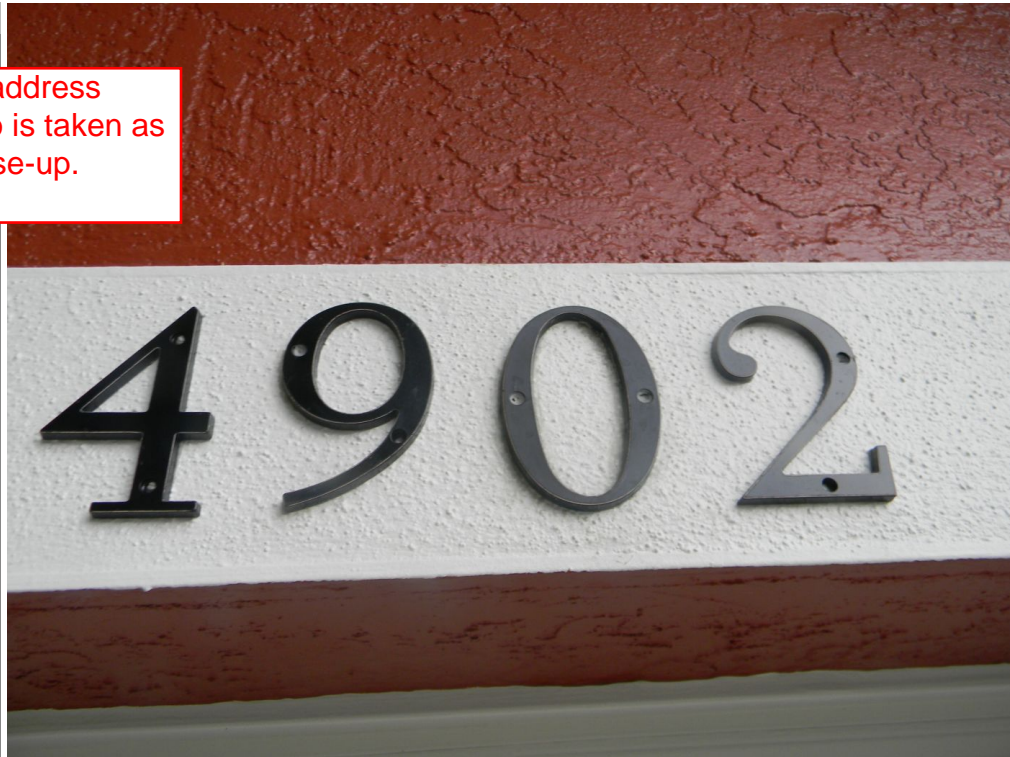
Photo Description:
Address

The address photo is taken as a close-up.

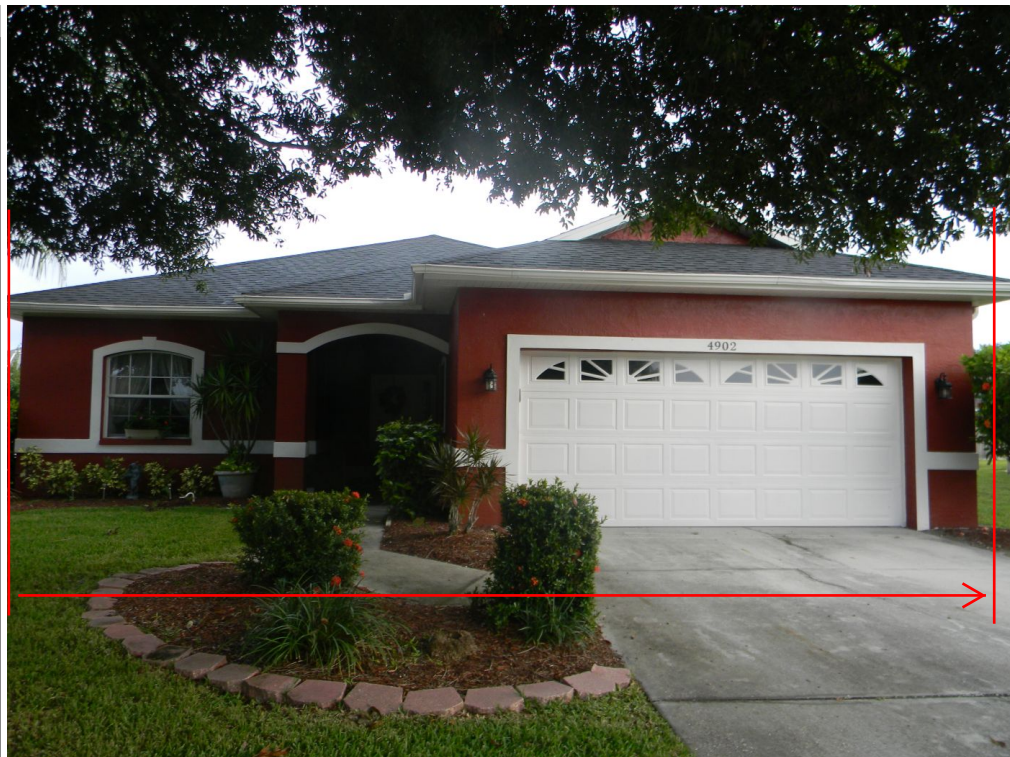
Photo Description:
Front

The front photo was taken straight-on due to obstructions on the sides of the house and driveway.

The image is positioned as close to the house as possible and still shows each corner of the front wall.

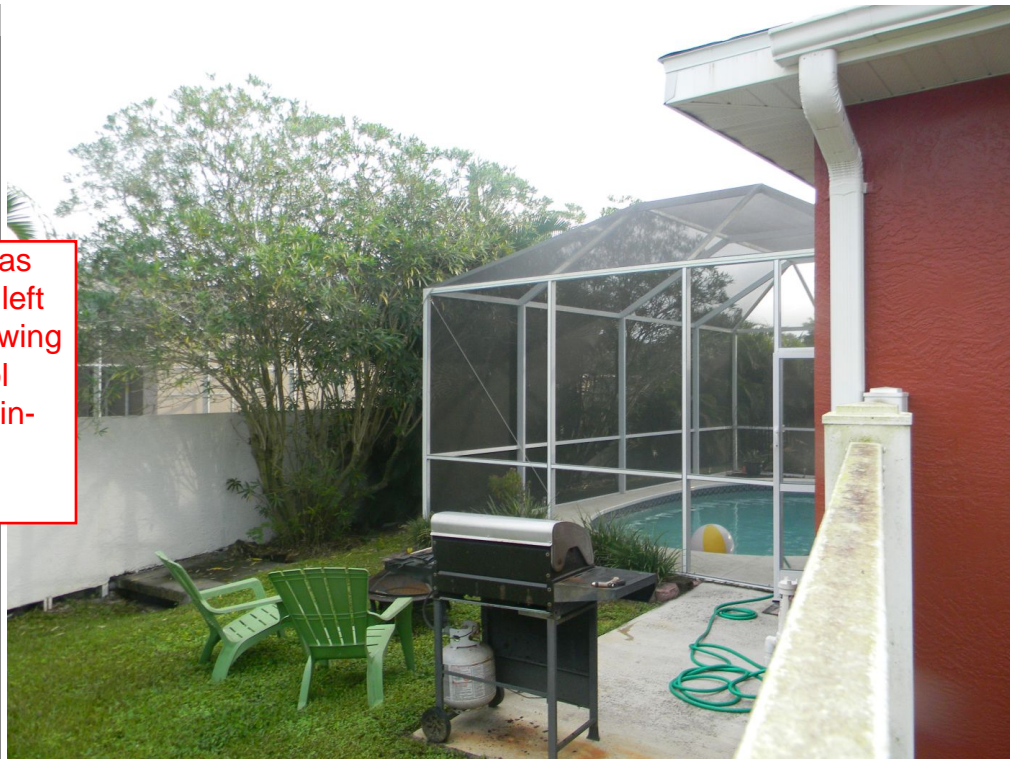
Rear

A rear photo was taken over the left side fence showing the screen pool enclosure and in-ground pool.

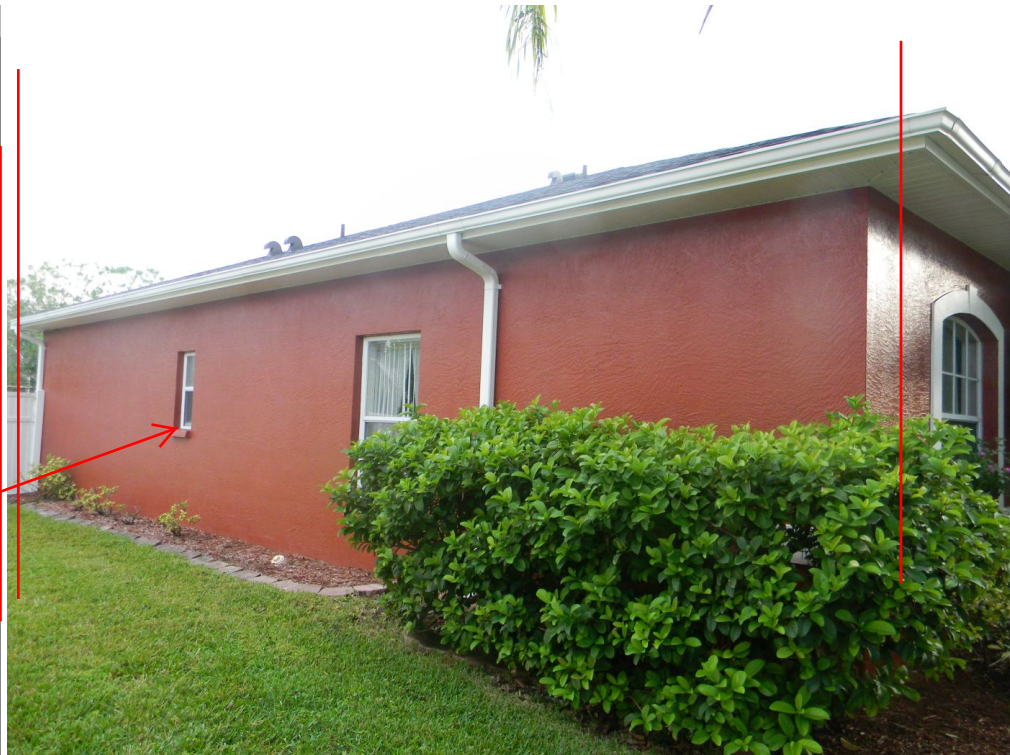
Left

The left photo shows each corner of the wall to show the length of the left side wall and roof shape.

The construction type is also verified by the inset on the windows.

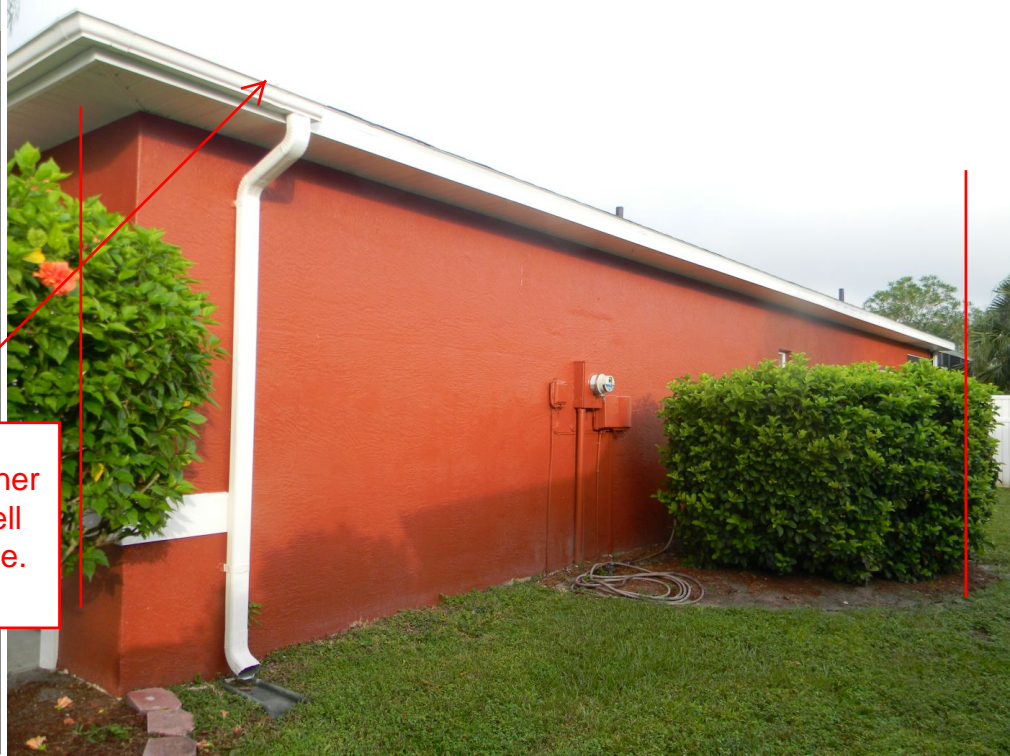
Right

The right photo shows each corner of the wall as well as the roof shape.

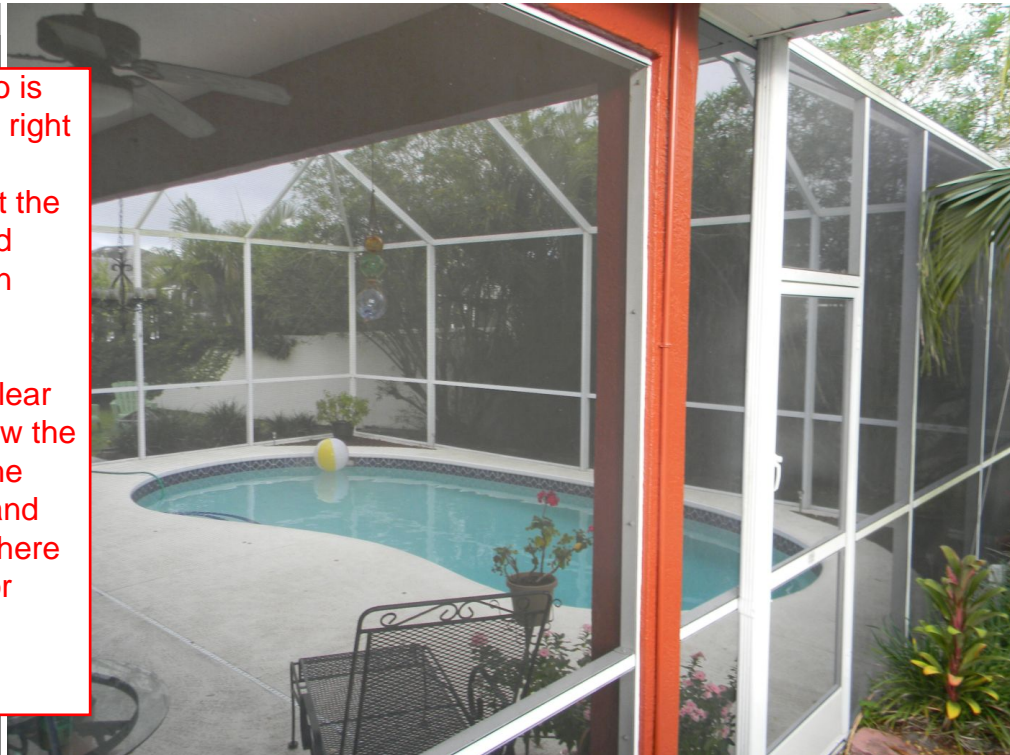
Pool

The pool photo is taken over the right side fence confirming that the pool is secured inside a screen enclosure.

The photo is clear enough to show the area around the pool decking and verifying that there is not a slide or diving board present.

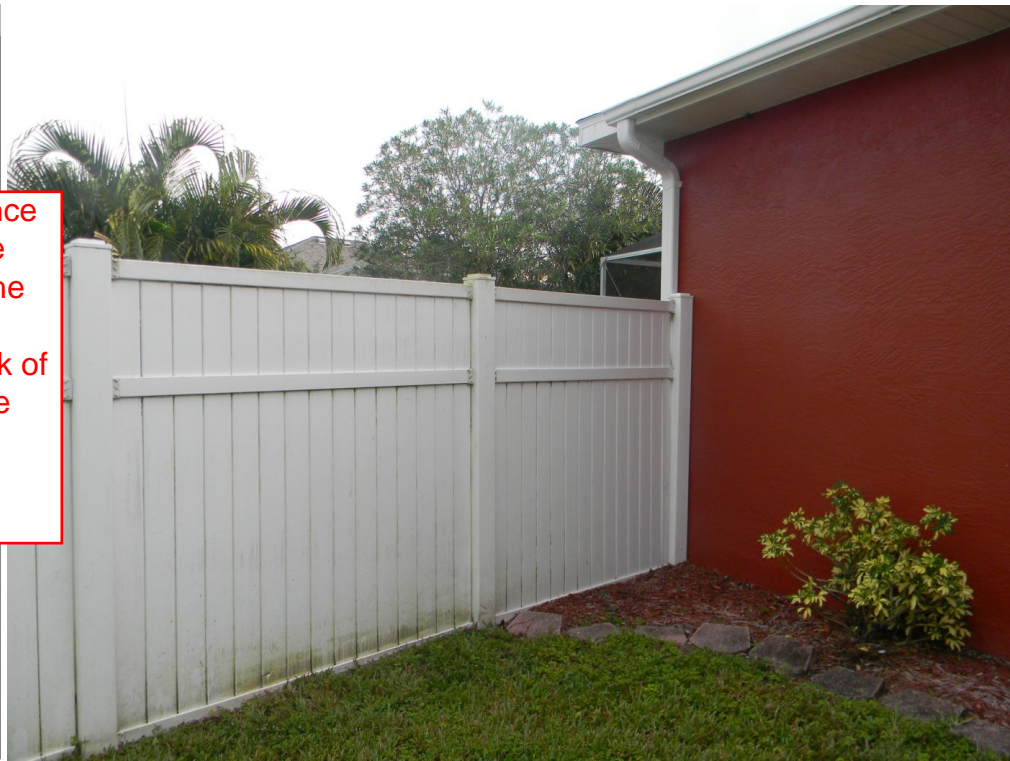
Photo Description:
Secured gate

The secured fence photo shows the relationship to the dwelling and confirms the lack of full access to the rear side of the property.

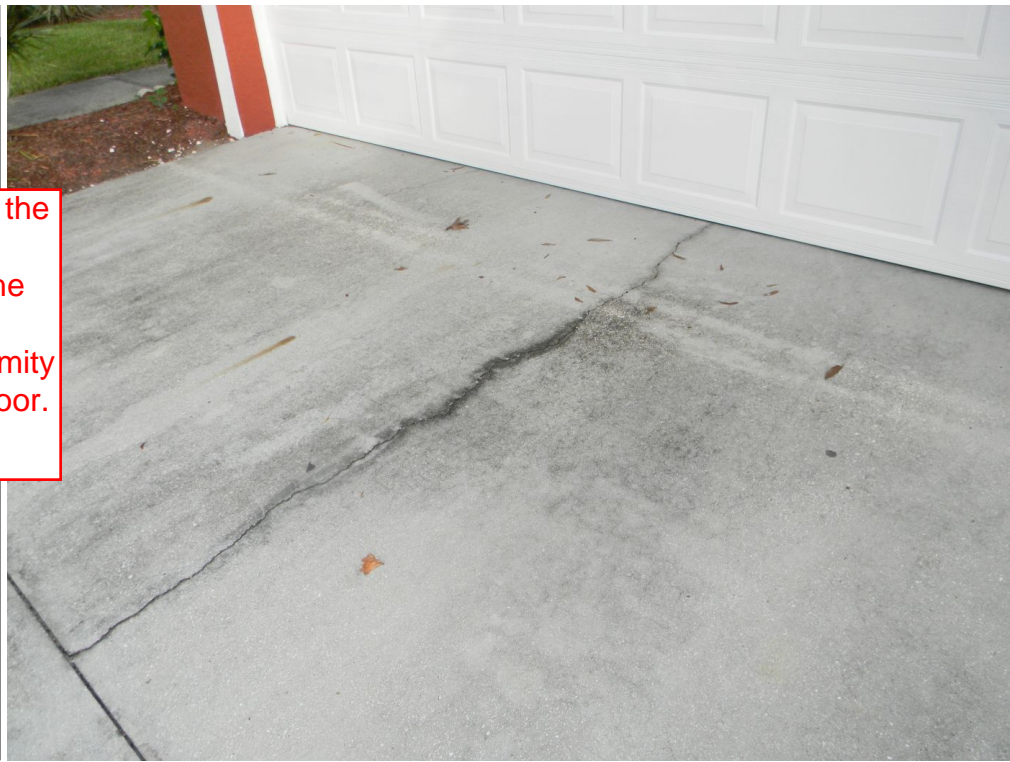
Photo Description:
Cracking-driveway

There was no access to the rear side due to secured gates, the rear and pool photos were taken over the left and right side fence.
 24. There is minor cracking in the driveway.
 26. A dog was heard barking inside the house.
 27. There is an enclosed pool on the rear side.

The cracking in the driveway photo clearly shows the severity of the crack and proximity to the garage door.

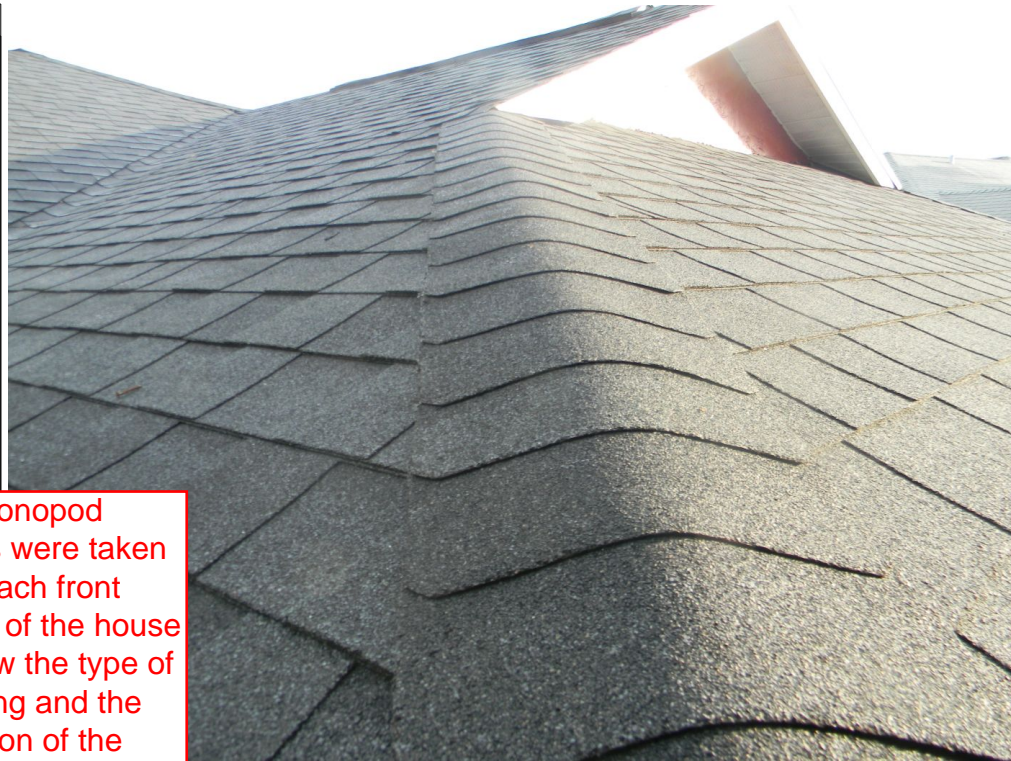
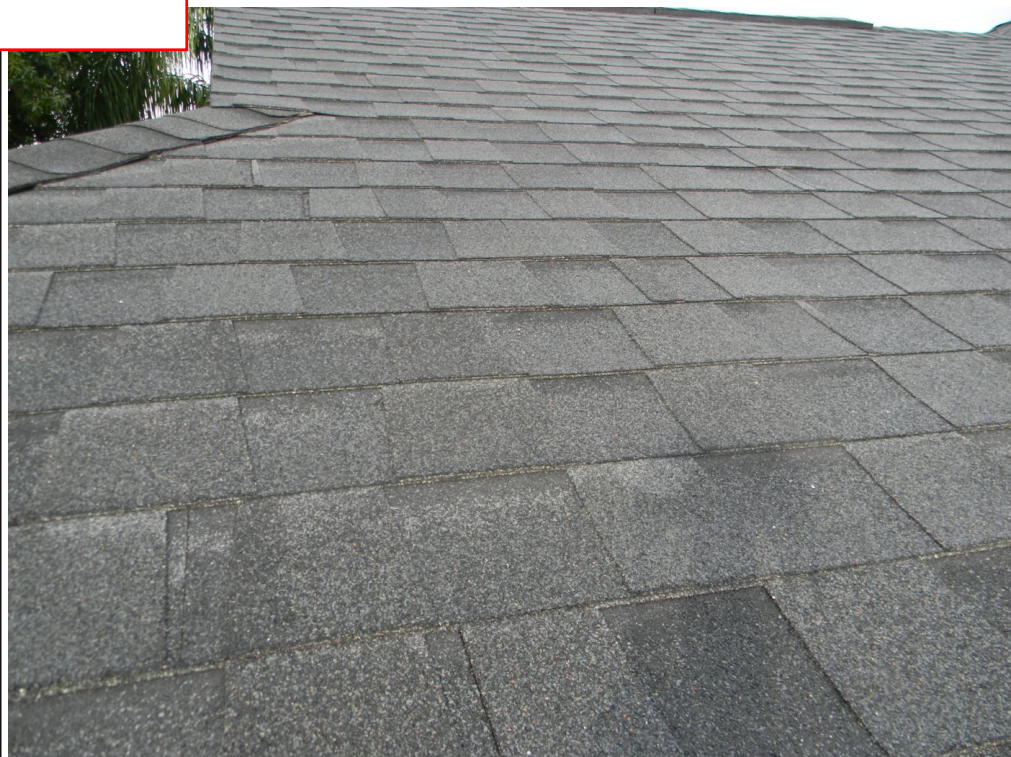
Roof

The monopod photos were taken from each front corner of the house to show the type of covering and the condition of the roof.
