Client Name: AMERICAN INTEGRITY INSURANCE

Policy #: AGD341397
Tracking #: 15-243-000375

City: BRADENTON State: FL Zip: 34203
 Telephone: Coverage Amount: 240000.0000 Year Built: 1996 Square Footage: 1483

INSPECTION SURVEY -- OVS-W2

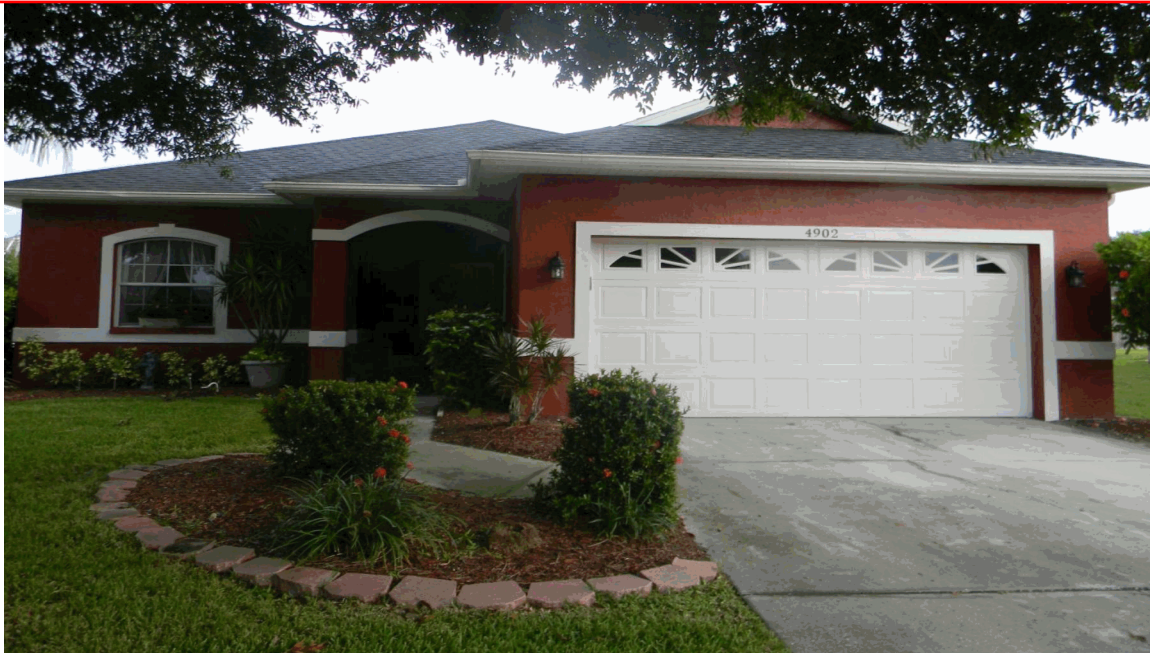
Your front photo is the leading cover of the electronic portfolio that is presented to our customer. This is the 'showcase' photo and we should make every effort to provide the highest quality image as possible.
